MIRABAY PILOT PROJECT REPORT

9/25/2014

By: Ingenium, Inc./Carl A. Hazenberg, P.E.

MiraBay Pilot Project Report

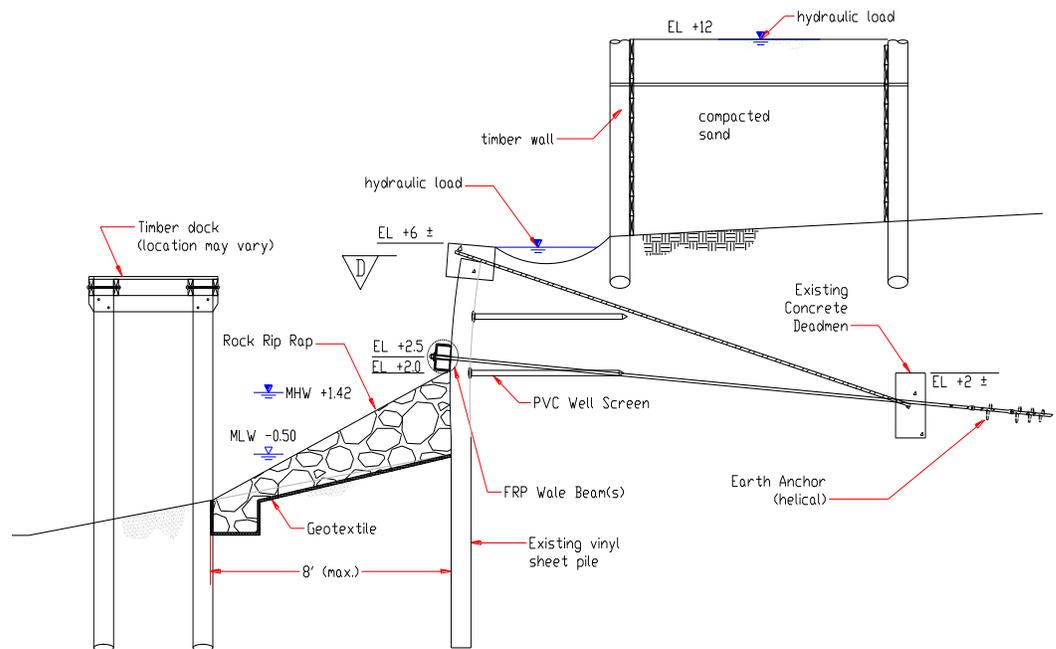
Typical Section of Option #1

Involved the use of a pair of rectangular fiberglass wale beams to support the lower part of the existing vinyl sheet pile. These wale beams were anchored back with a helical screw anchors, which were driven to a distance sufficient to develop the required holding capacity. Anchor installation torques and pulling capacities varied significantly due to the varying soil conditions. Rock rip rap was piled up at the base of the seawall to provide additional stabilization. Maximum slope of the rip rap is 2 horizontal to 1 vertical and has a horizontal impact of approximately 8 feet in front of the existing seawall.

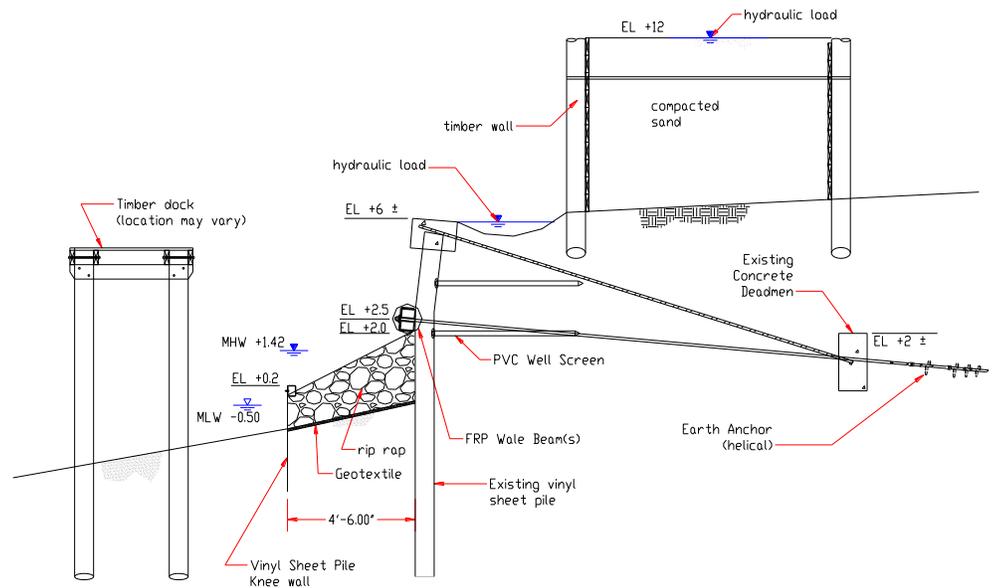
Typical Section of Option #2

Identical to Option #1, with the exception of a vinyl sheet pile “knee” wall. This was installed to intersect the toe of the rip rap and reduce the horizontal impact waterside of the wall. Sheets were driven 1’ to 1.5’ short of design depth due to refusal from hard soils. Despite this installation struggle, sufficient stability was still achieved. Horizontal impact for this option is approximately 4.5 feet and would cause less conflict with water craft than Option #1.

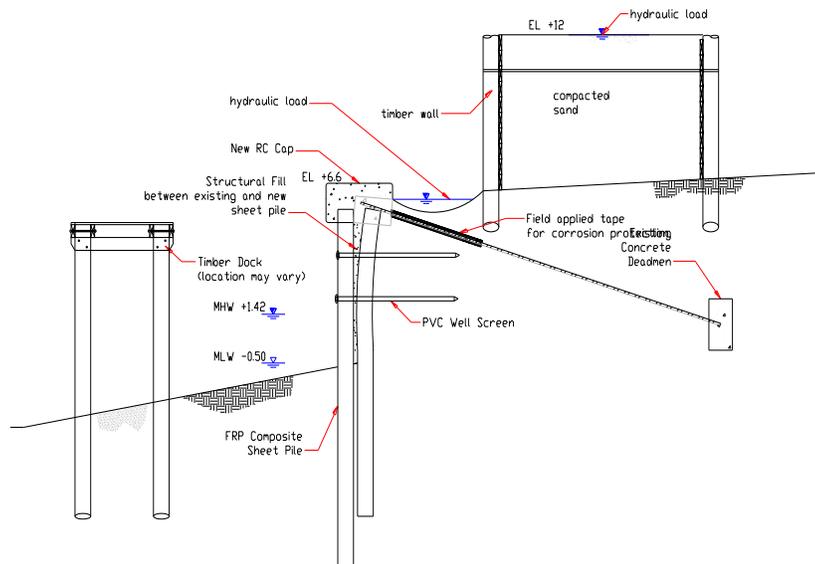
Typical Section of Option #3

This involved driving of new FRP sheet pile directly in front of existing vinyl sheet pile seawall. New concrete cap was poured at the top to tie the new sheets in with the existing concrete cap and existing deadman system. New sheet piles were driven approximately 0.5' short of design penetration due to conflict of vibratory hammer with existing concrete cap. In spite of this conflict and slightly shorter sheet, sufficient stability was provided by the dense soils.

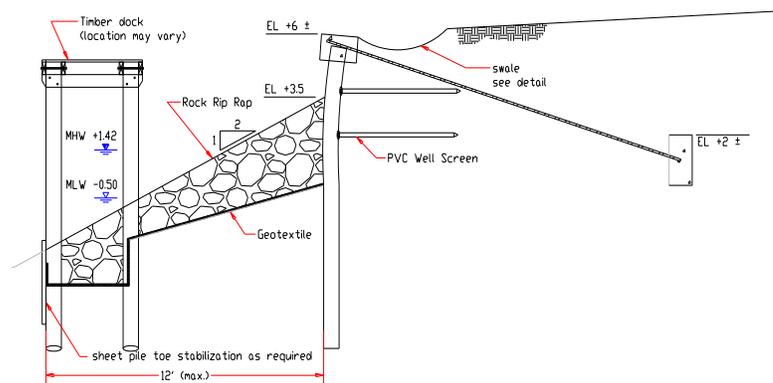
Typical Section Option #4

A fourth option represents the proposed solution that resulted from past litigation. This option utilizes rock rip rap placed in front of the existing vinyl sheet pile seawall. The option does not incorporate an earth anchor, resulting in a larger rip rap footprint. Rock would be piled up at a greater elevation on the wall, and encroach waterside approximately 12 feet.

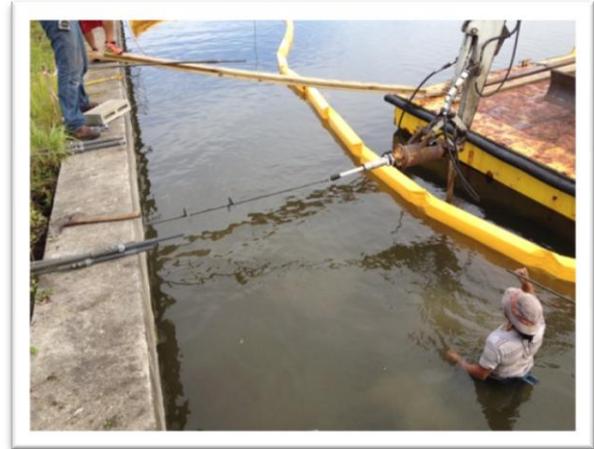
Photo of Helical Earth Anchor Installation

Variability of site soils and the presence of compacted shell, presented unpredictability when driving of helical earth anchors. Contractor overtorqued and broke several anchor shafts while attempting to drive through lenses of compacted shell. At Seagrass site, contractor excavated to confirm the presence of shell layer where anchors were breaking. At the Tybee location one of the anchors had to be driven longer than the design length due to very loose soil. Installation of the anchor system proved to be the most difficult aspect of the project. Future design and construction should require anchor flexibility to account for these varying site conditions.

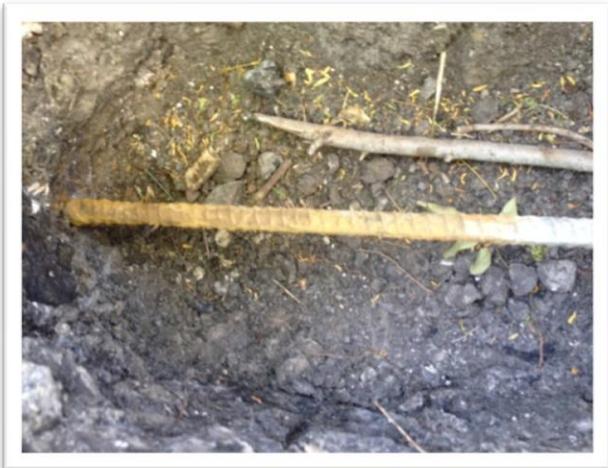
Photo of corrosion on existing tie-rod

Furthermore, it is worth noting that existing tie-rods showed signs of corrosion beyond three feet behind the cap. This is unusual since most tie rods tend to corrode immediately behind the cap due to greater presence of oxygen at the ground surface. This may indicate that soils present are chemically aggressive for typical steel. However, no measurements were taken for section loss to determine whether significant structural loss will occur over the life of the structure.

Anchors, rods, and hardware installed on the pilot project for options #1 and #2 were treated by a thermal diffusion galvanization for superior corrosion protection.

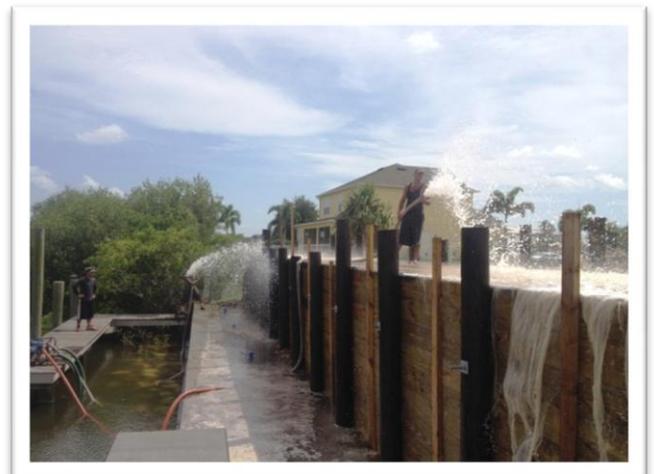
Timber walls were constructed approximately 5' behind the existing seawall. The intent was to simulate segmental block retaining walls present throughout the community. These timber walls were filled with compacted sand and built 6' tall. This is 25% higher than the 4.75' high segmental block walls, and corresponds to a 25% greater surcharge being applied to the seawall than typically present. Next, water was pumped immediately within the backfill areas of both the retaining and seawalls to induce a full saturated hydraulic load. While impossible to know

the exact hydraulic loading of the existing seawall throughout the community during heavy rain events, I estimate the loading applied for the pilot project is 100% to 250% greater than the current seawall normally experiences.

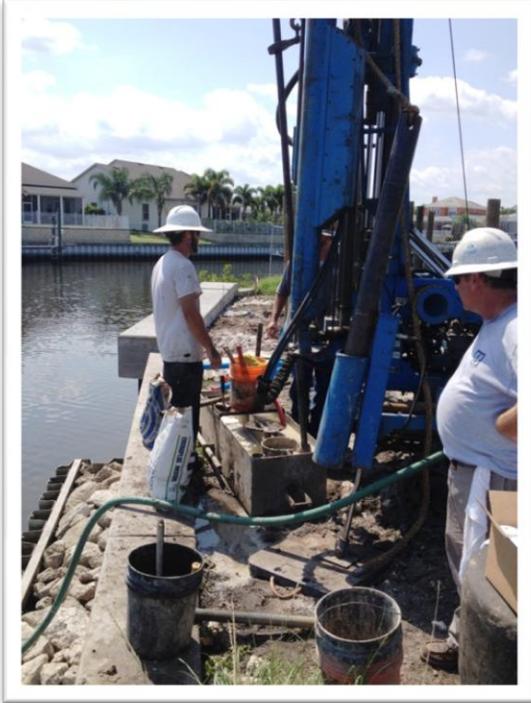
Photo of inclinometer installation

Inclinometers and surveying were performed along the two properties to measure movement along the seawall. Initial baseline readings were taken prior to construction of the timber retaining wall. Subsequent measurements for movement were taken after each hydraulic loading. In summary, all of the options constructed for the pilot project showed little to no movement. The little movement noted in a few inclinometers, were likely due to voids present in the backfill soils. Survey information along the concrete cap and front of the sheet pile, showed no appreciable movement of the seawall and coincided with the results obtained from the inclinometers.
