MIRABAY PILOT PROJECT REPORT

9/25/2014

By: Ingenium, Inc./Carl A. Hazenberg, P.E.

MiraBay Pilot Project Report

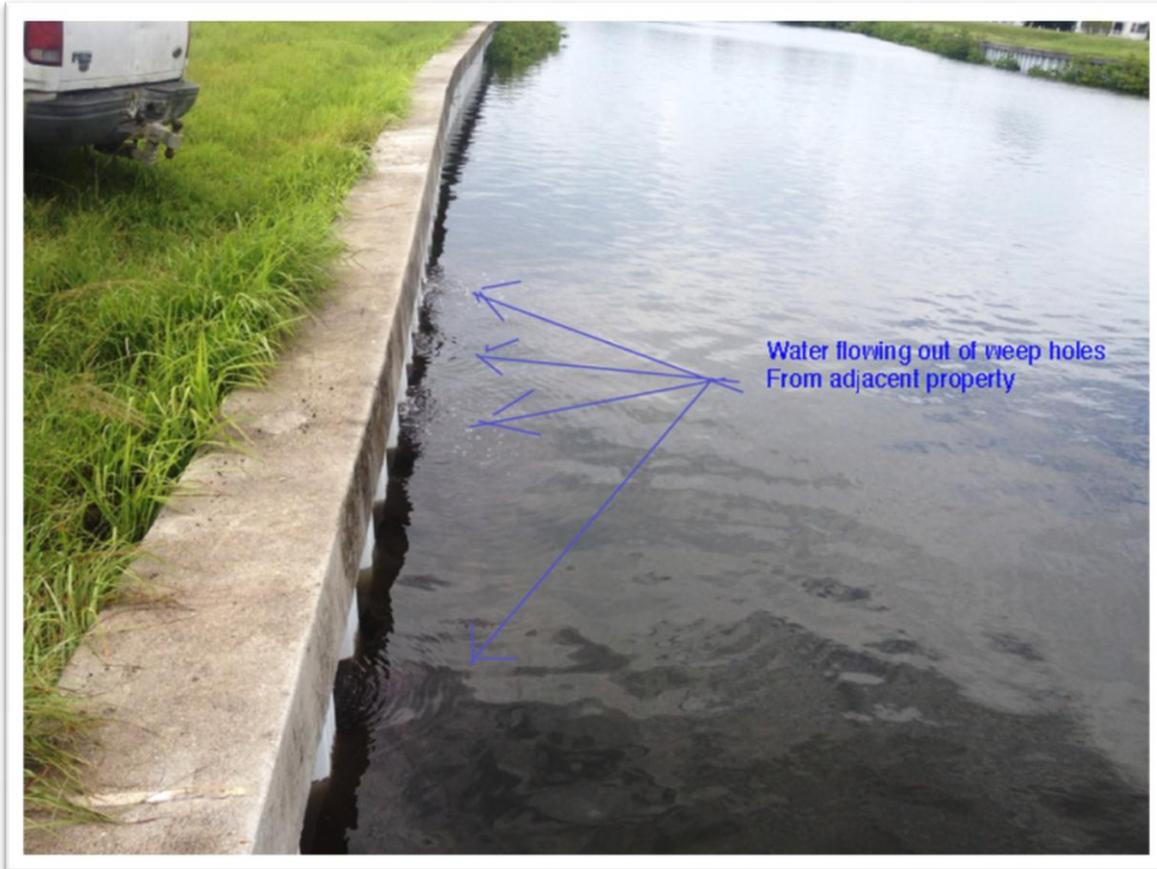
Also, due to lack of compaction of backfill and presence of voids, much of the water flowed parallel to the seawall and flowed out at drainage(weep) holes of the seawall on the adjacent property.
